TRANSMITTAL OF RESPONSE TO COLORADO DEPARTMENT OF HEALTH  
AND ENVIRONMENT (CDPHE) COMMENTS OF DECOMMISSIONING  
CLOSEOUT REPORT FOR THE 881 CLOSURE PROJECT - DWF-098-05

## SUMMARY OF B881 CLOSEOUT REPORT RESPONSE TO COMMENTS TO CDPHE

**Quantification of Airborne Dust Concentrations  
Downwind of the Building 881 Demolition**

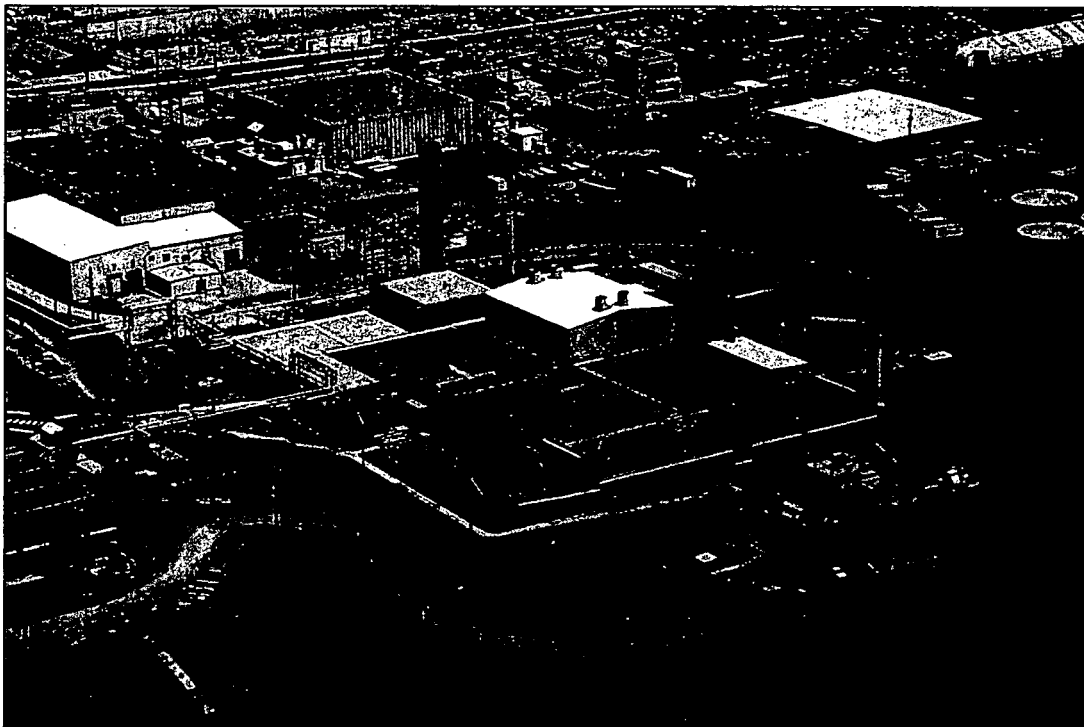
**Figure 1-1. Aerial View of Building 881 from the South-Southwest.**

The Building 881 was used as an enriched uranium component manufacturing facility from 1953 to 1966, when stainless steel machining became the principle building activity. Radiological contamination within the facility was remediated prior to demolition; the structure was classified as unrestricted release (less than 200 picocuries per 100 square centimeters [ $\text{pCi}/100 \text{ cm}^2$ ])<sup>1</sup> at the time of demolition. Therefore, though radiological operations once occurred within the facility, there was no significant radiological emissions potential associated with Building 881 demolition. Building 881 is shown in Figure 1-1.
